TECHNICAL SERVICE BULLETINS

2/24/89

TECHNICAL SERVICE BULLETIN

ERROR CODE INFORMATION FOR ALL SOFTWARE THRU 4.00.00

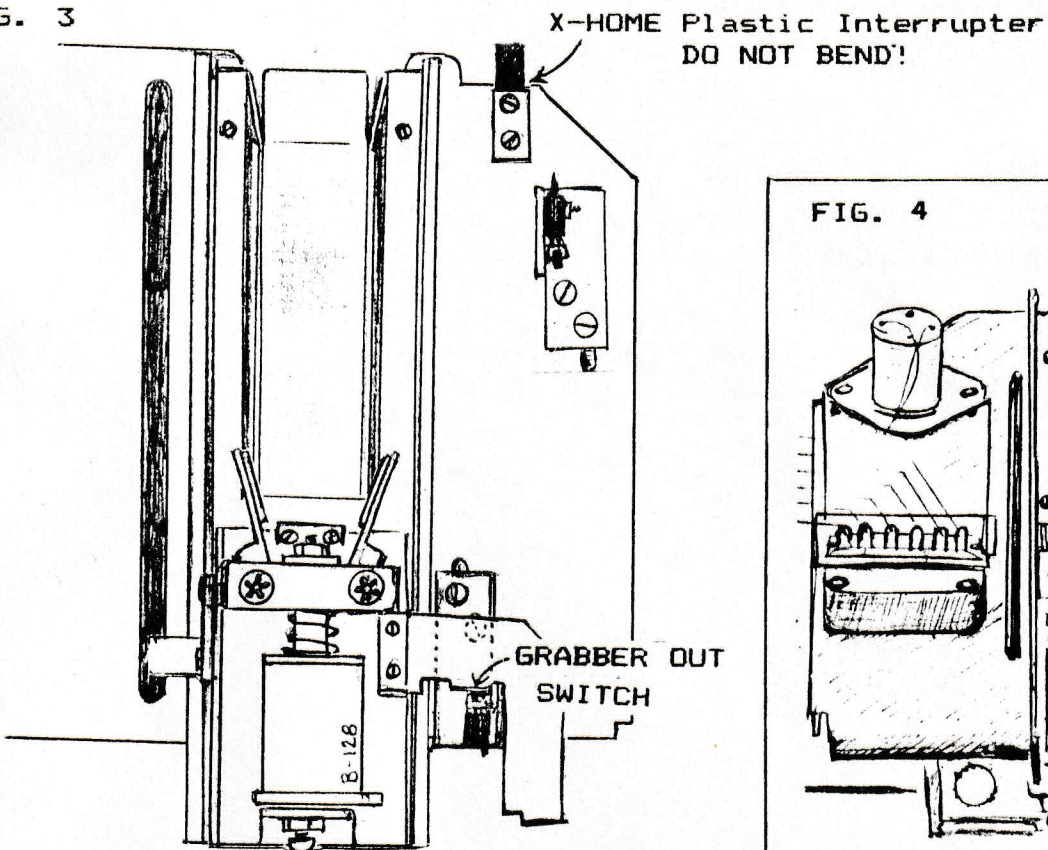
FIG. 3

(D) GRABBER OUT SWITCH IS NOT WORKING AND "Z" MOTOR IS TRYING TO PULL THE GRABBER OUT AGAINST REAR STOP. (FIG. 3) REPLACE SWITCH.
8. GRABBER DOESN'T MOVE AND Z MOTOR DOESN'T RUN. (A) "Z" MOTOR BAD. (FIG. 4) CHECK VOLTAGE ACROSS MOTOR TERMINALS. IT ALTERNATES DEPENDING ON DIRECTION. SEE BULLETIN 13A.

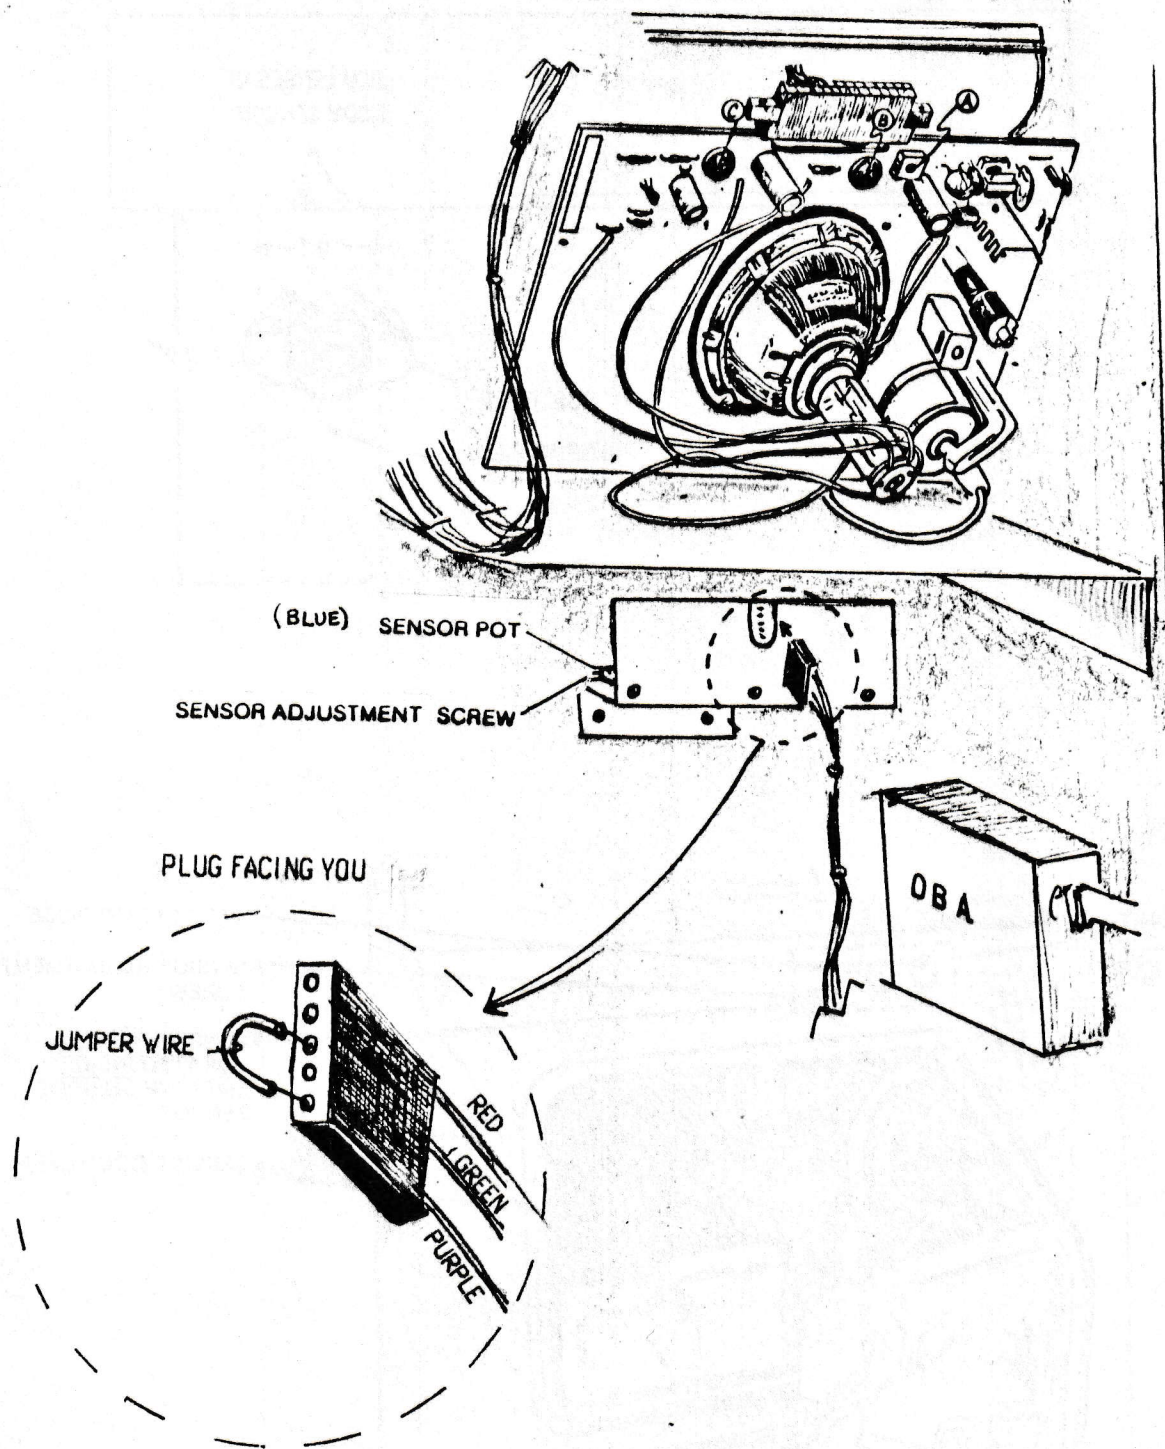
FIG. 3

VIEW INSIDE VENDOR
FROM SMALL REAR DOOR

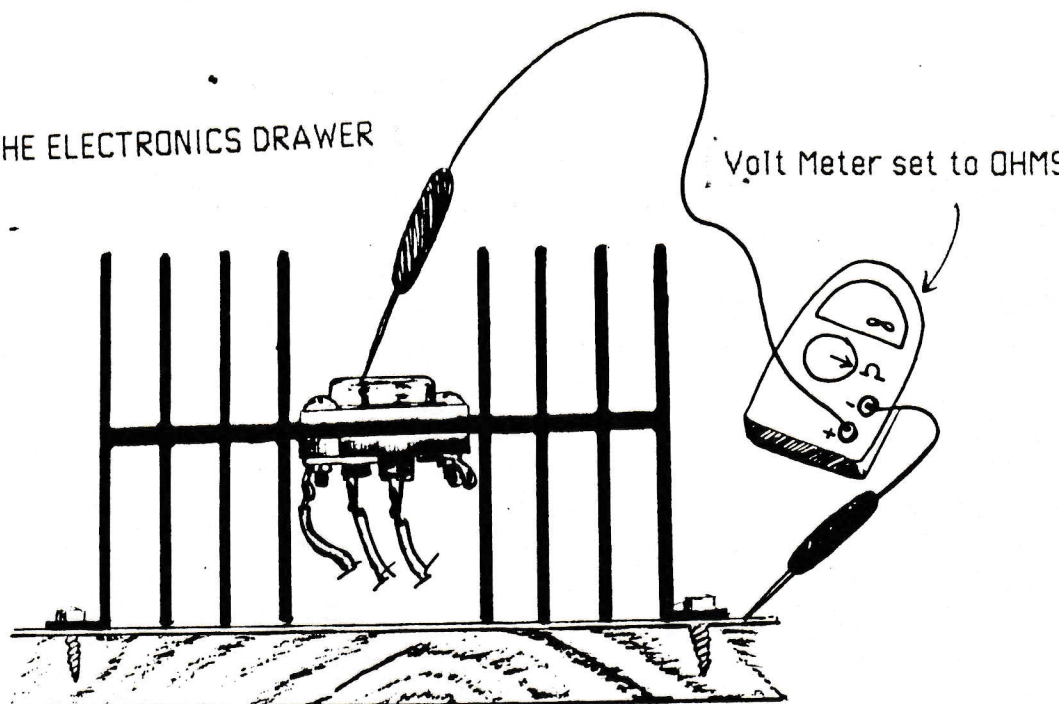
FIG. 1

WE HAVE FOUND A PROBLEM WHICH CAUSES THE BODY DETECTOR TO HANG UP WITH A YES CONDITION AFTER THE VENDOR TURNS ON THE BILL ACCEPTOR. THIS IS NOT USUALLY A BODY SENSOR PROBLEM, RATHER IT IS A SHORTED POWER TRANSISTOR IN THE MOTOR CONTROLLER POWER SUPPLY. OTHER SYMPTOMS ARE YOU MAY NOTICE THE TRANSPORT MOVING AT A MUCH HIGHER THAN NORMAL SPEED; THE ROBOT MAY HOME OK AT THE BOTTOM (Y) AXIS OF THE MACHINE BUT WILL NOT FIND HORIZONTAL (X) HOME AT THE ACCESS DOOR WHILE TRYING TO VEND A TAPE TO A CUSTOMER.

REAR LEFT SIDE OF THE ELECTRONICS DRAWER

POWER TRANSISTOR AND HEAT SINK PART # A-3080: HEAT SINK ASSEMBLY

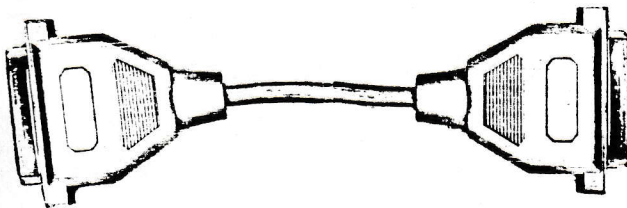
OUTPUT OF VIDEO VENDOR
RS-232 PORT
25 PIN PLUG (OUT)

FOR CUSTOMERS WHO WISH TO SET UP COMMUNICATIONS BETWEEN THEIR VIDEO VENDOR AND AN OUTSIDE COMPUTER THRU THE RS-232 INTERFACE, THE FOLLOWING INFORMATION WILL BE OF VALUE TO YOU.

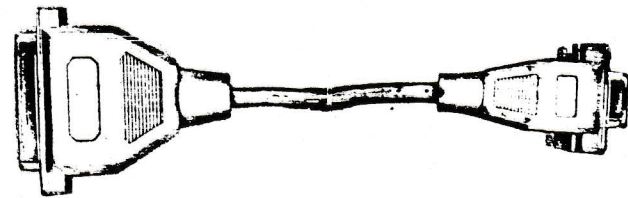
2	TxD	3
3	RxD	2
6	DSR	20
7	SIG GND	7
20	DTR	6
4	RTS	
5	CTS

OUTPUT OF VIDEO VENDOR
RS-232 PORT
25 PIN PLUG (OUT)

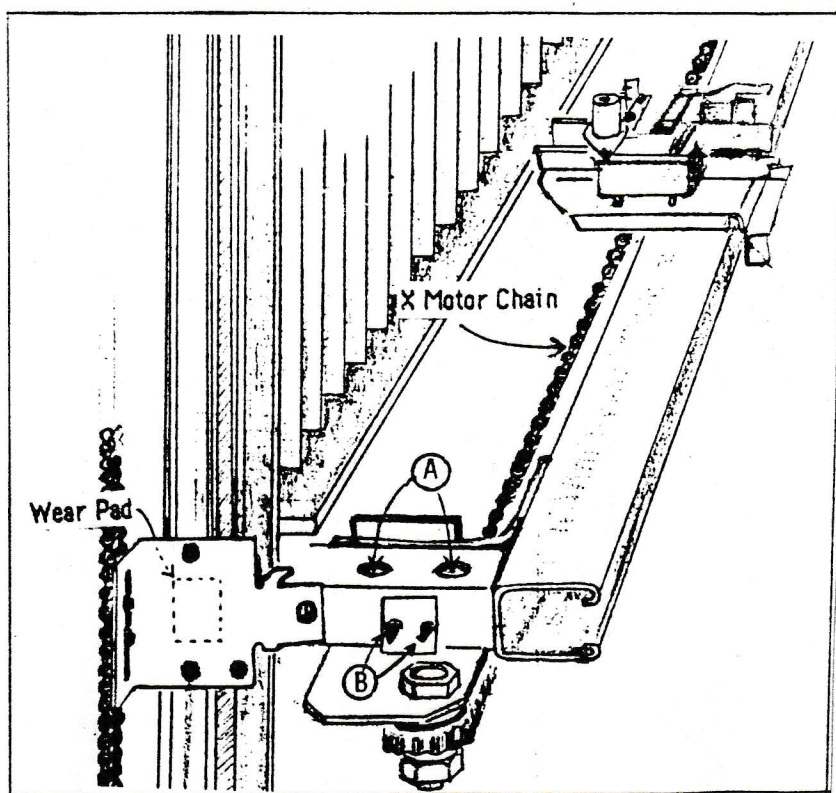
In both of these cases, if the retriever moves or if the chain hangs down too much, the repair is to tighten the chain.

Loosen the locking nut located through holes at point "A". Then, to tighten the chain, tighten the nuts at point "B". Or, to loosen the chain, loosen the nuts at point "B".

When finished lock down the nuts located through holes at point "A".

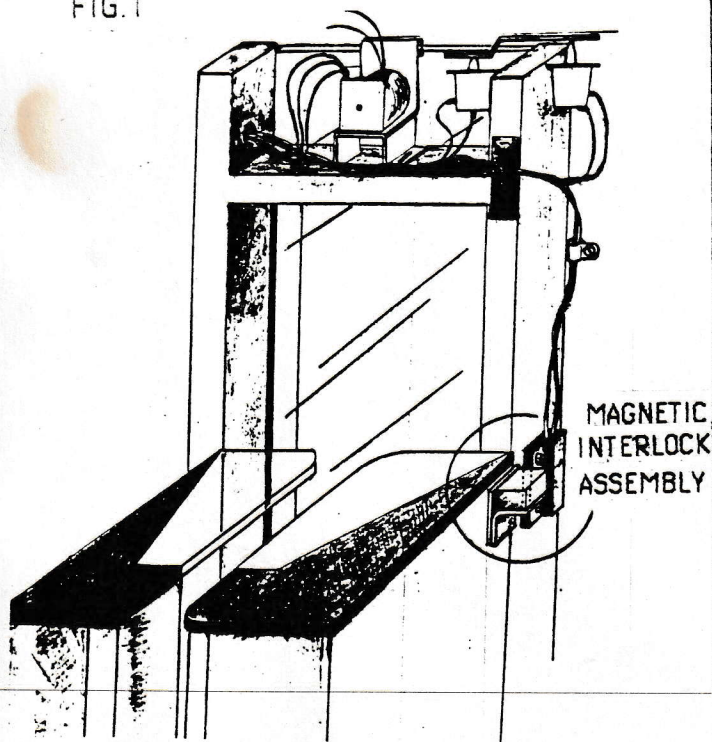
FIG. 1

Test: using the keypad in Diagnostics, Feature 19; raise the transport assembly so it is level to the access door in its normal delivery position and so that the magnetic interlock assembly (Fig. 1) is aligned. Pressing the "1" key should activate the door latch and green light allowing the door to be raised.

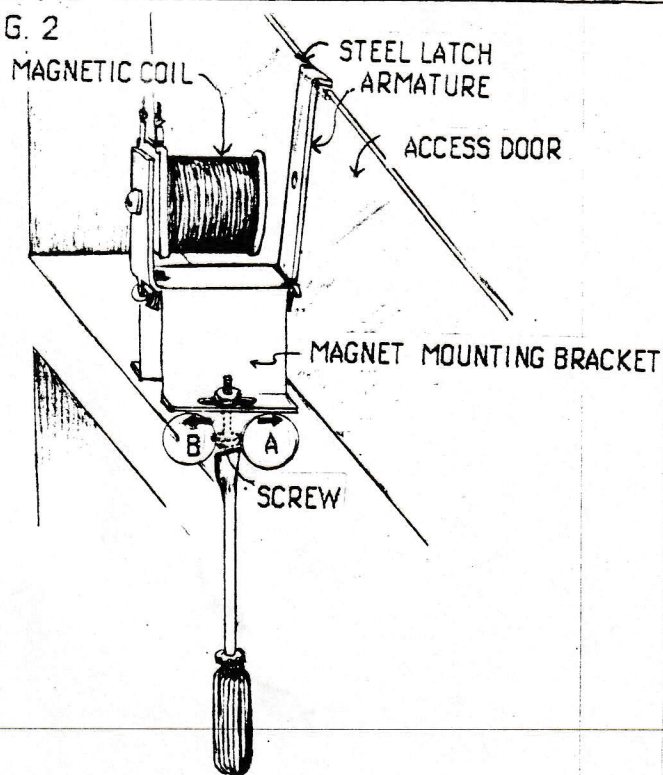
FIG. 2

If the magnet is too close to the armature, it will pull but not draw the latch far enough to allow the door to open. You will need to loosen the two screws and slide the bracket $1/32"$ to $1/16"$ away from the armature (Fig. 2, arrow B). Retighten screws and check operation.

To do this, loosen the two screws (one on each leg) of the magnet mounting bracket (see Fig. 2). Slide the bracket $1/32"$ to $1/16"$ towards the armature (Fig. 2, arrow A). Retighten the screws and check operation to be sure you did not position the magnet **too close** to the armature. This would cause the door latch to be unable to clear the top of the door, also resulting in the access door not opening with the green light lit.

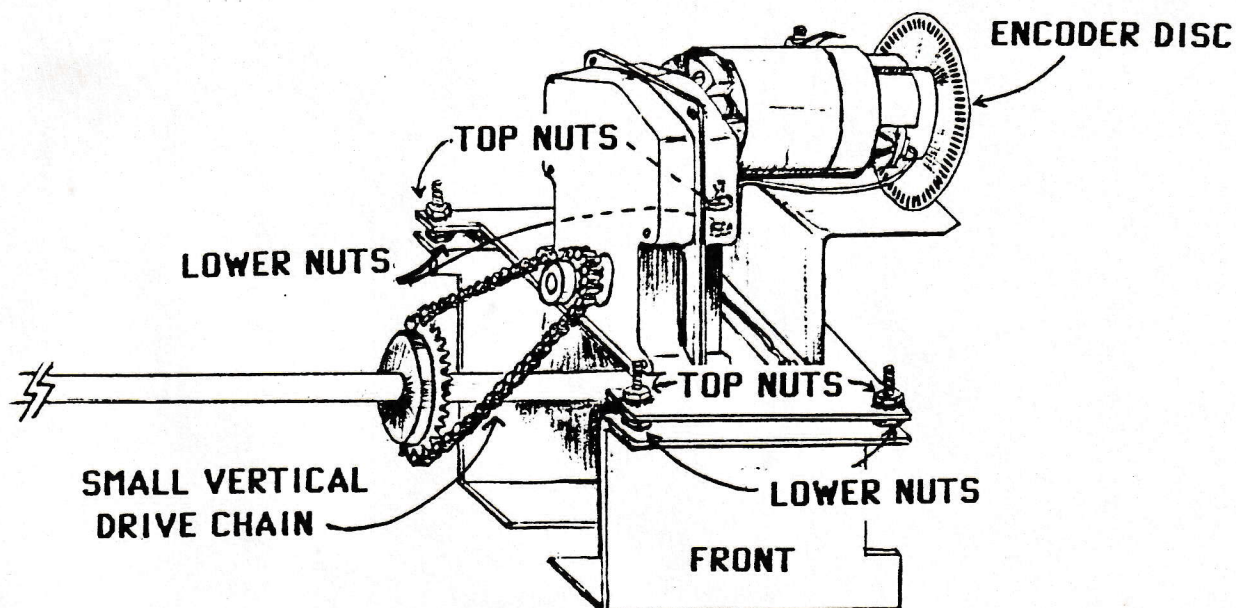
PROBLEM: If you notice that when renting a movie from locations below the access door, slots 200 - 320, the transport mechanism aligns correctly with the door entry. When renting from locations **above** the access door, 1 - 120, however, the mechanism does not line up with the access door and can be off by $1/4"$ - $1/2"$. The probable reason for this is that the vertical drive chain is too loose, so that when the motor reverses to bring the mechanism back, pulses (counts) are lost due to more chain looseness than was originally compensated for by the software.

TEST: Manually turn the encoder disc (See Diagram) until the chain begins to move. Stop and turn the disc in the opposite direction. If you can rotate the disc **more** than $1/2$ turn, the chain needs to be tightened.

ADJUSTMENT: Loosen the top nuts shown in the diagram. (If only a slight adjustment is needed, only the front ones need loosening, otherwise loosen all four top nuts.) Screw the lower nuts upward making gradual adjustments until the chain moves by turning the encoder disc a $1/4$ - $1/2$ rotation in the opposite direction. Don't forget to retighten the top locking nuts.
